Investigation of  
Horn 1 water system

# Horn 1 suction line failing - similar to previous Horn 2 problem

## Horn 1 suction line failing

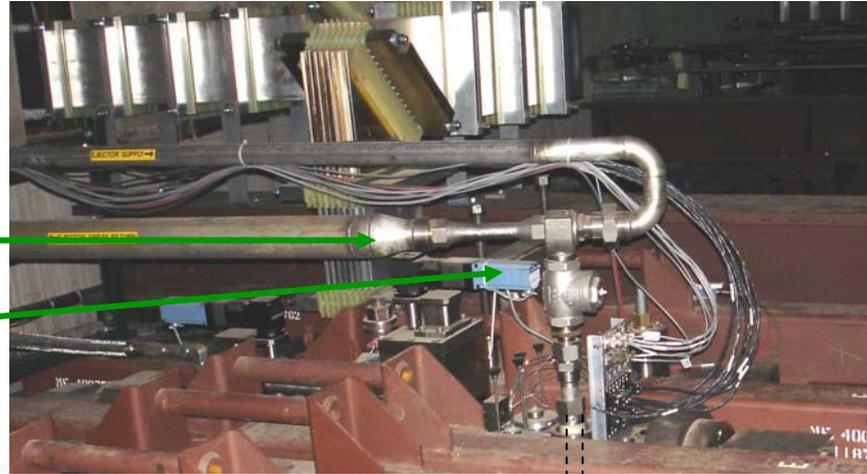
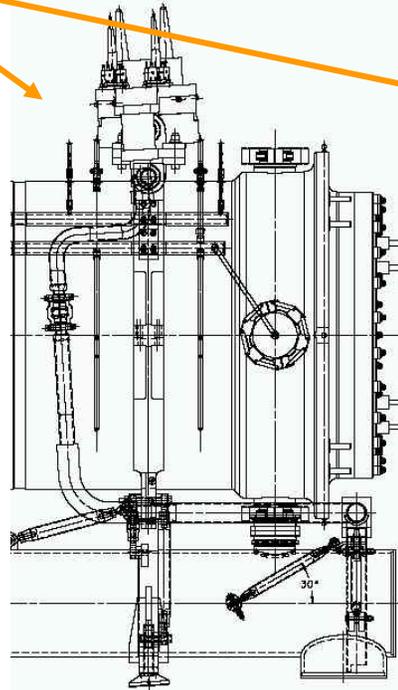
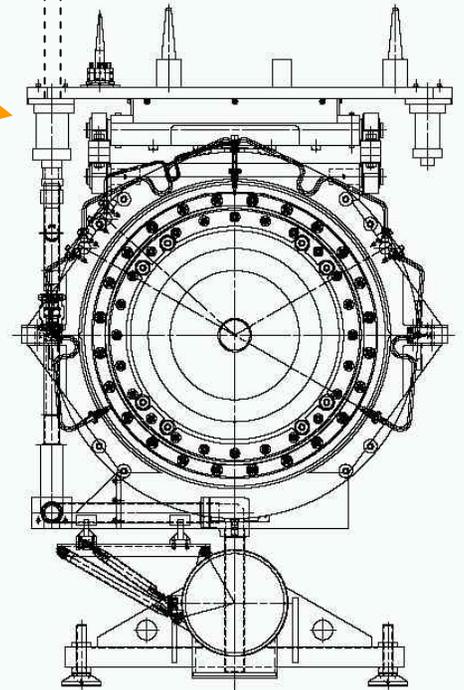
Ceramic electrical insulation  
*hole here in suction line  
drawing in air  
reducing water suction*

This is the 5<sup>th</sup> ceramic failure.

Horn 1 still has the old style.

Horn 1 spare is being outfitted with all-new style;  
estimated completion June 6, then ready for installation.

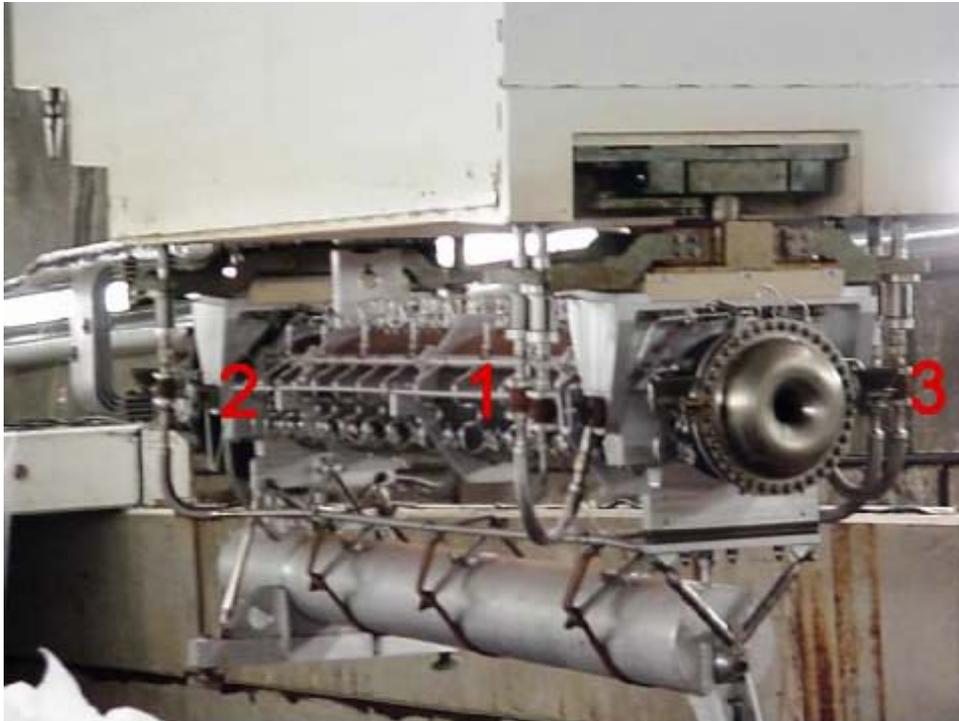
Point	Doserate @ 1 foot (mr/hour)	Doserate On Contact (mr/hour)
1	35000	75000
2	40000	75000
3	35000	80000

Horn 1 residual radiation map as of Aug, 2006 - should be higher (x2 ?) now

# Replace horn rather than repair - but save for offline repair in 2009/2010
