Horn 2 repair update

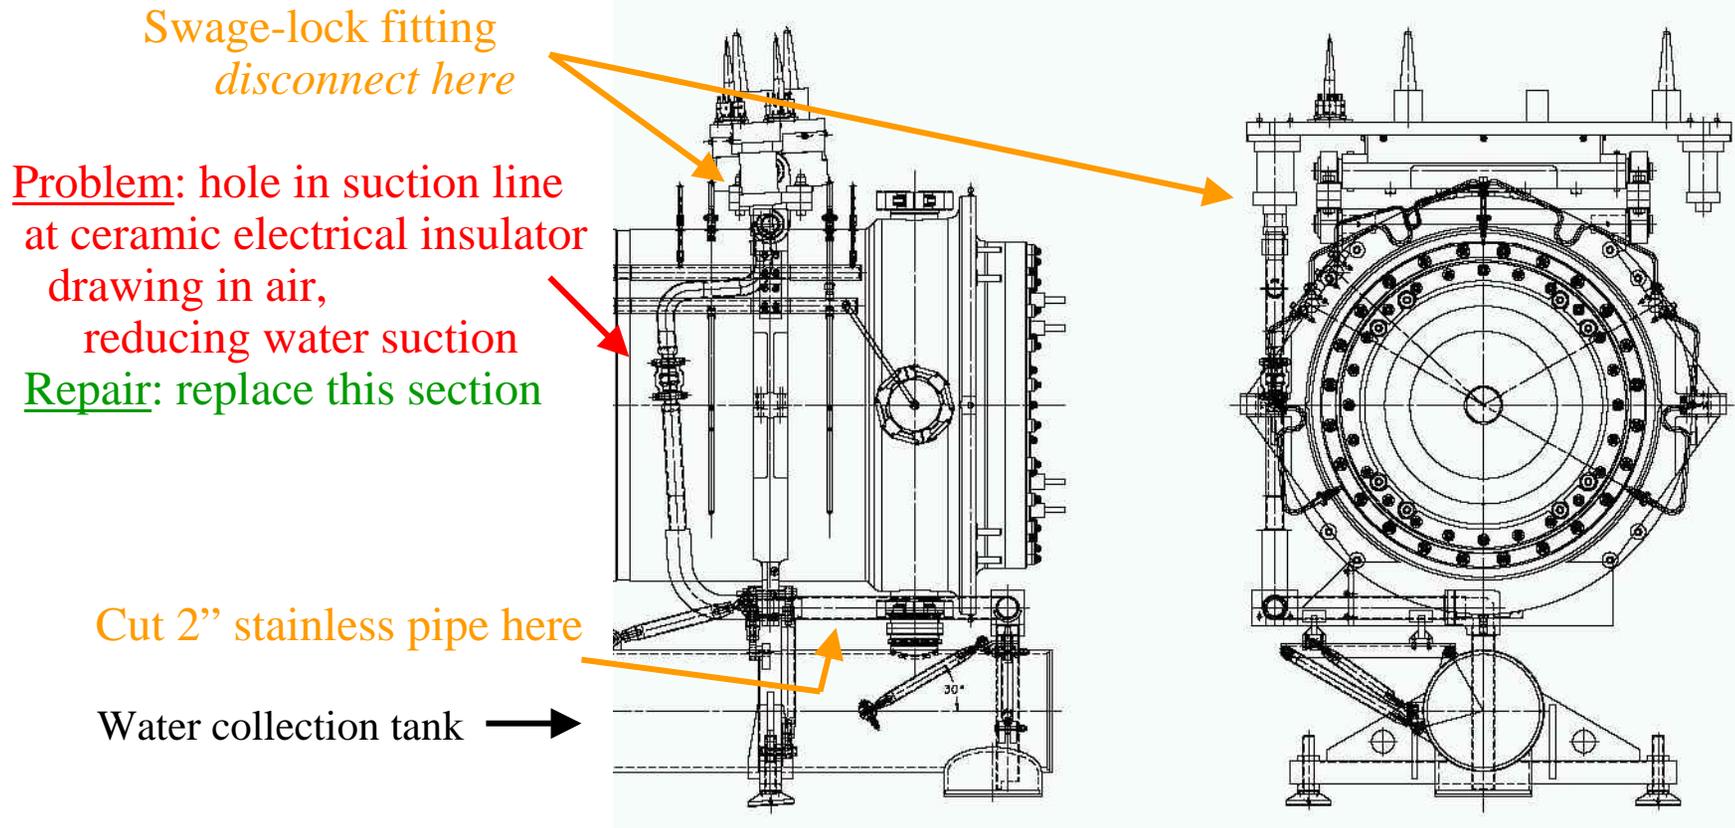
Symptom: Suction of water back from Horn 2 could not keep up with water spray rate to the horn – *water built up in the horn*

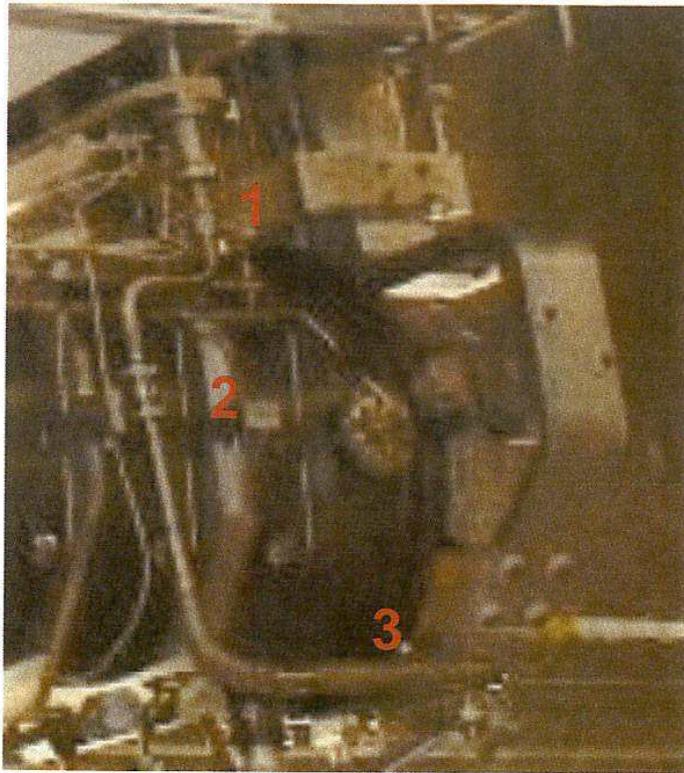
30 R/hr – 50 R/hr in chase around horn before horn removal

All Doserates in R/hr

After horn removal	O.C.	1 foot	~ 18"
1	8	4.5	3
2	7	4	3
3	5	3	2.5

Allowable ~ 1 minute per person at arms length

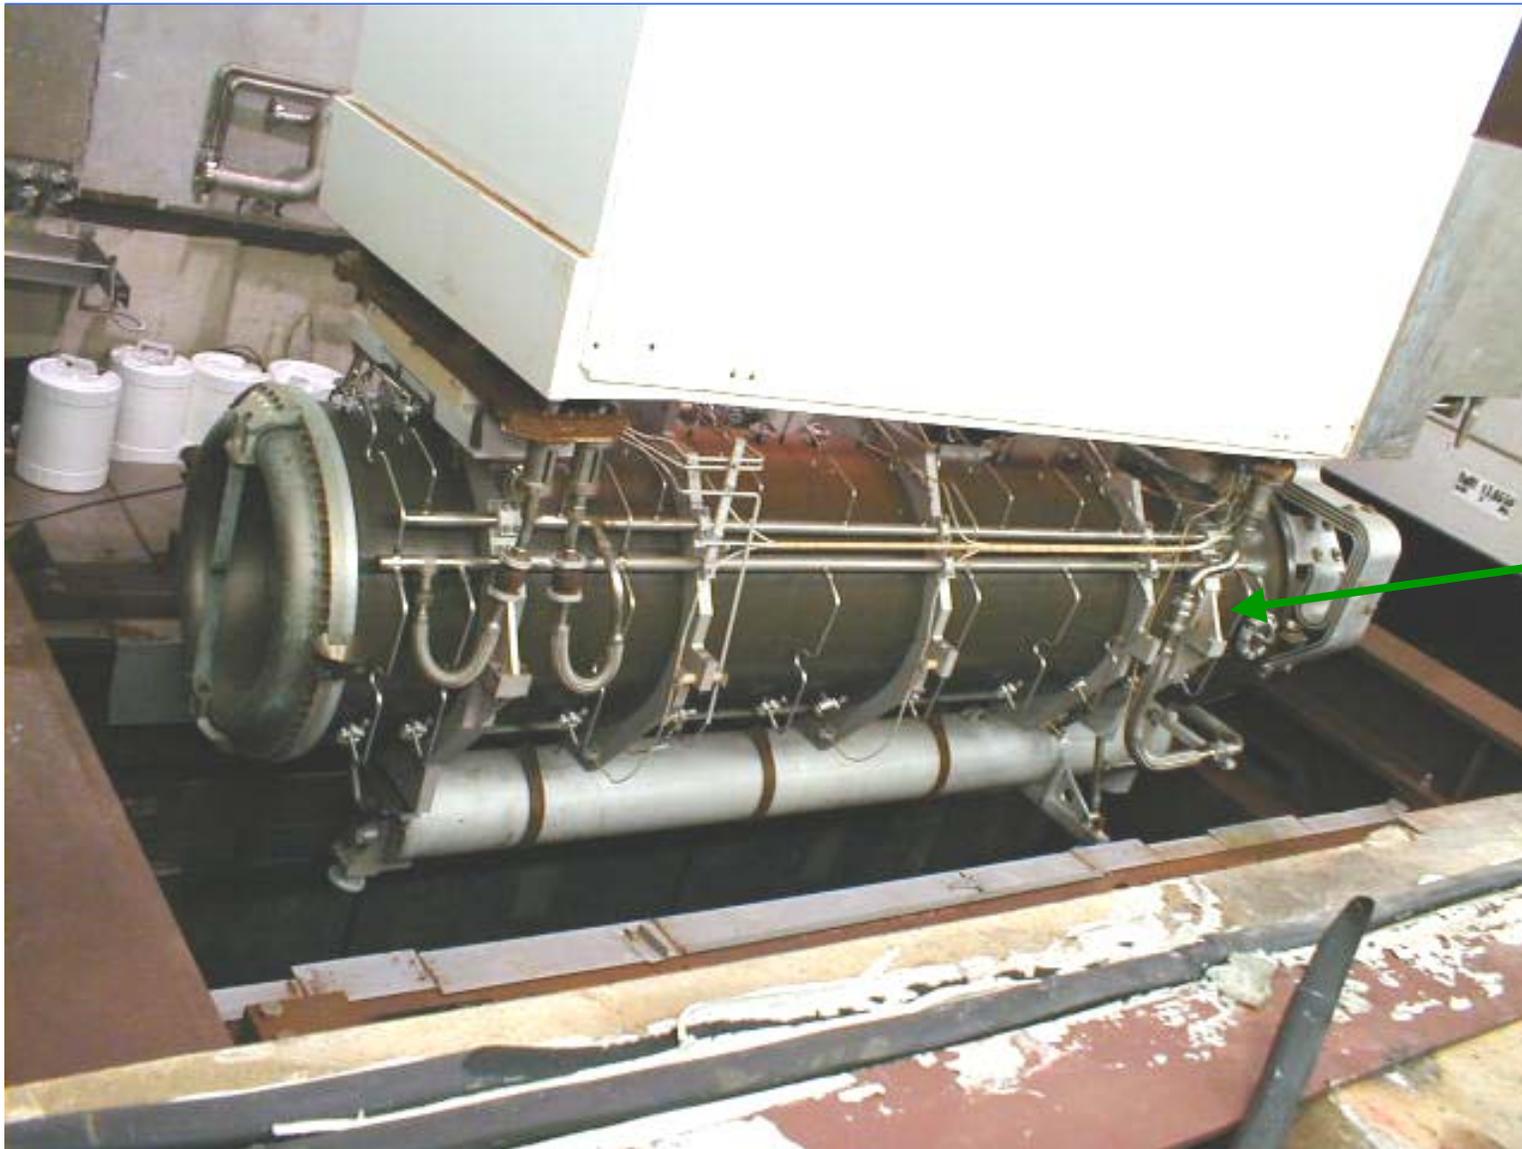
Repaired horn going into target pile

Repaired
line

Status: bad water-line has been successfully replaced !

- On April 18, bad section was replaced
- Horn is back in target pile
- Tests so far:
 - « Water flow now works as designed, no sign of water or air leaks
 - « Hi-Pot of horn is acceptable
(changed deionization bottle to improve water resistivity)
- Before declaring total victory,
 - want to see repair survive vibration from horn pulsing
 - Pulse test must wait for completion of installation
of new motorized switch on 13.8 kV power*

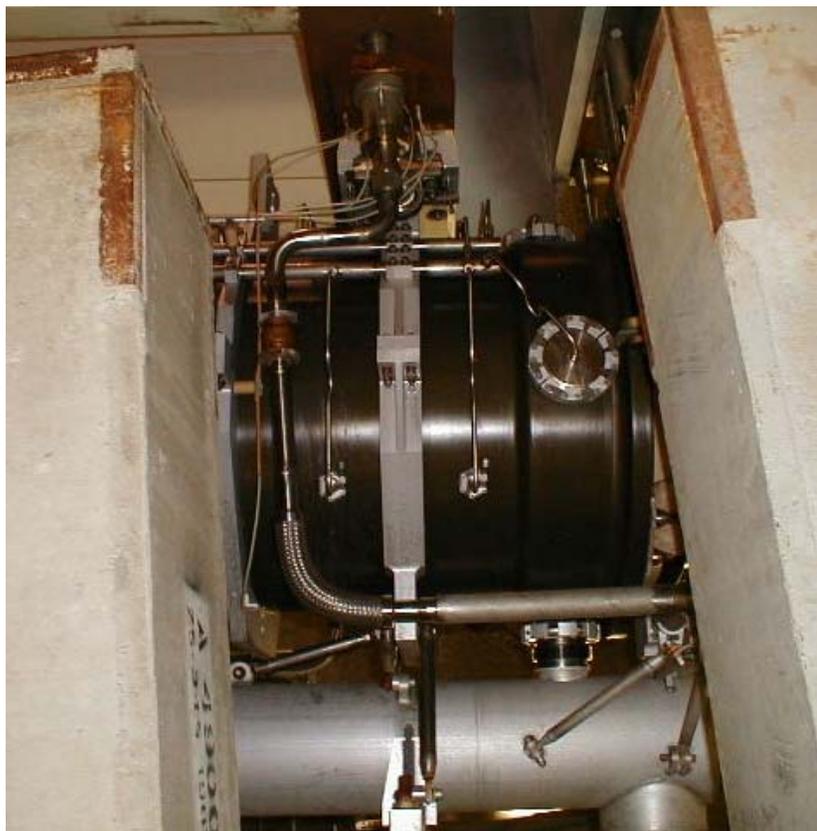
Set up temporary shielding
with slot

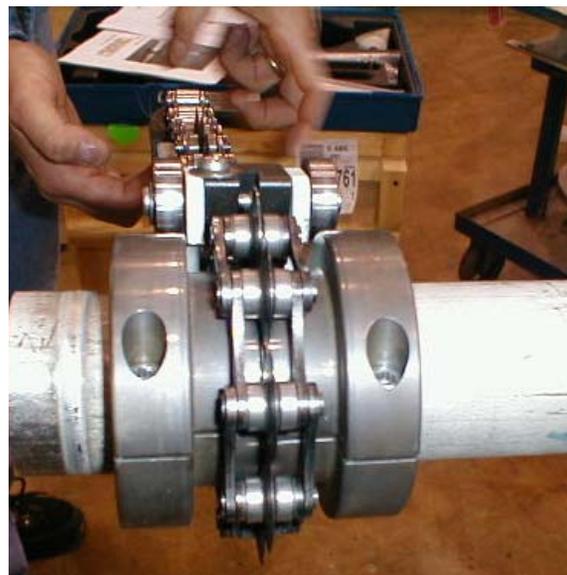
Cut 2"
steel pipe

No chips

Note
alignment
jig

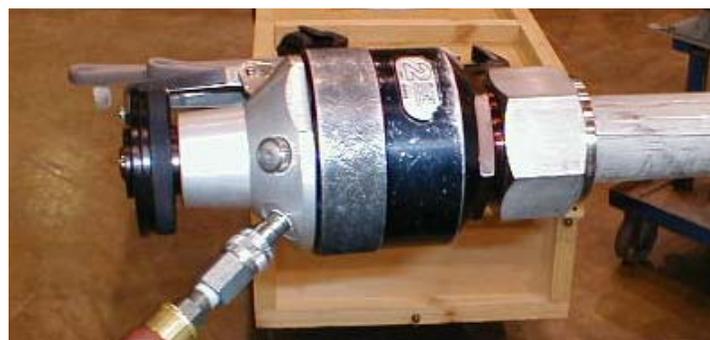
Hydraulic Swaging of compression fitting
