# NuMI Horn Water Line Ceramic Isolator Overview

NuMI Horn Water Line  
Ceramic Isolator  
Special Report AEM  
July 16, 2007

## Horn Water Spray Supply Line Electrical Isolators- Operational Experience With First NuMI Horns

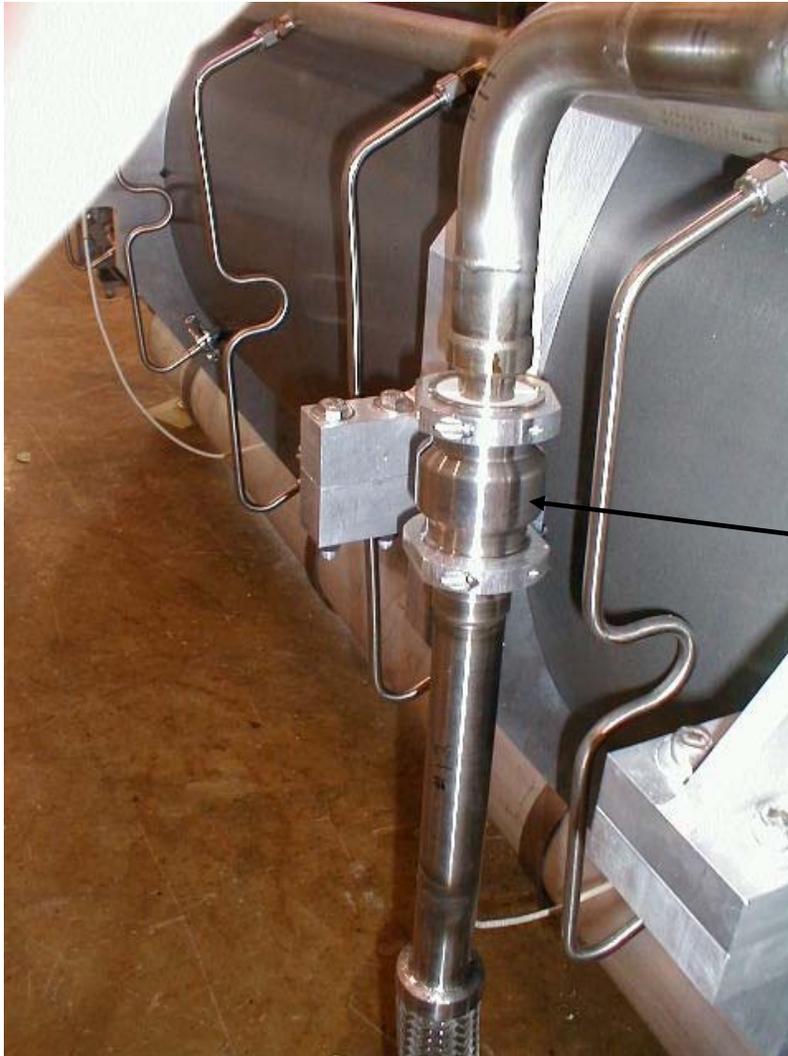
# PH2-01 Failed Ceramic Isolator Location

*Horn 2 Suction Line  
PH2-01 Prior to  
Beamline  
Installation*

*Electrical Isolator  
Assembly Shown  
with Invar 36  
Structural Support  
Shell- DS Beam  
Right*

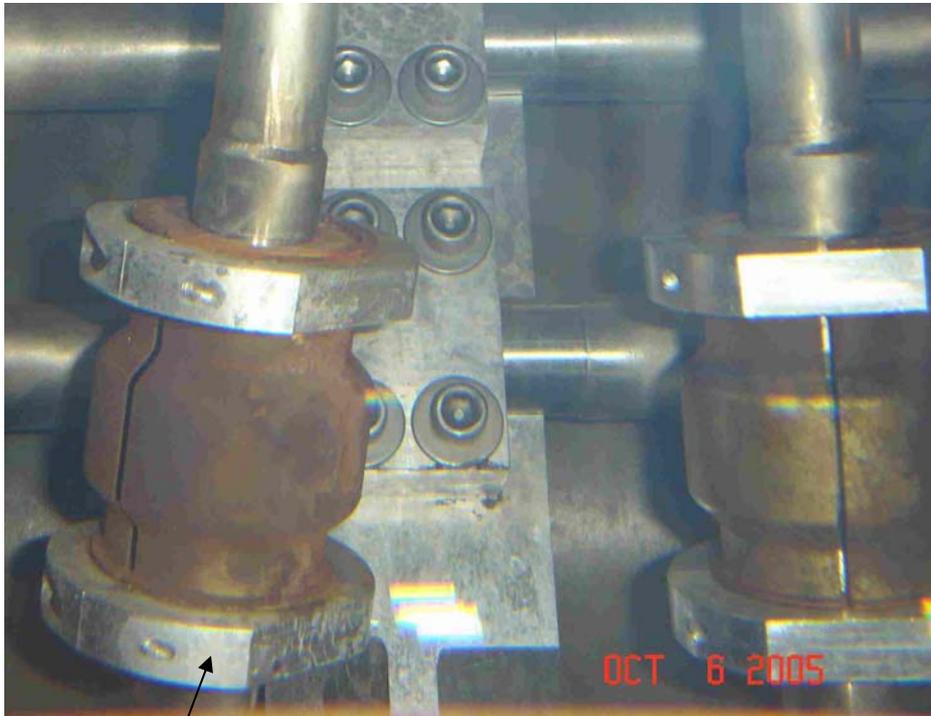
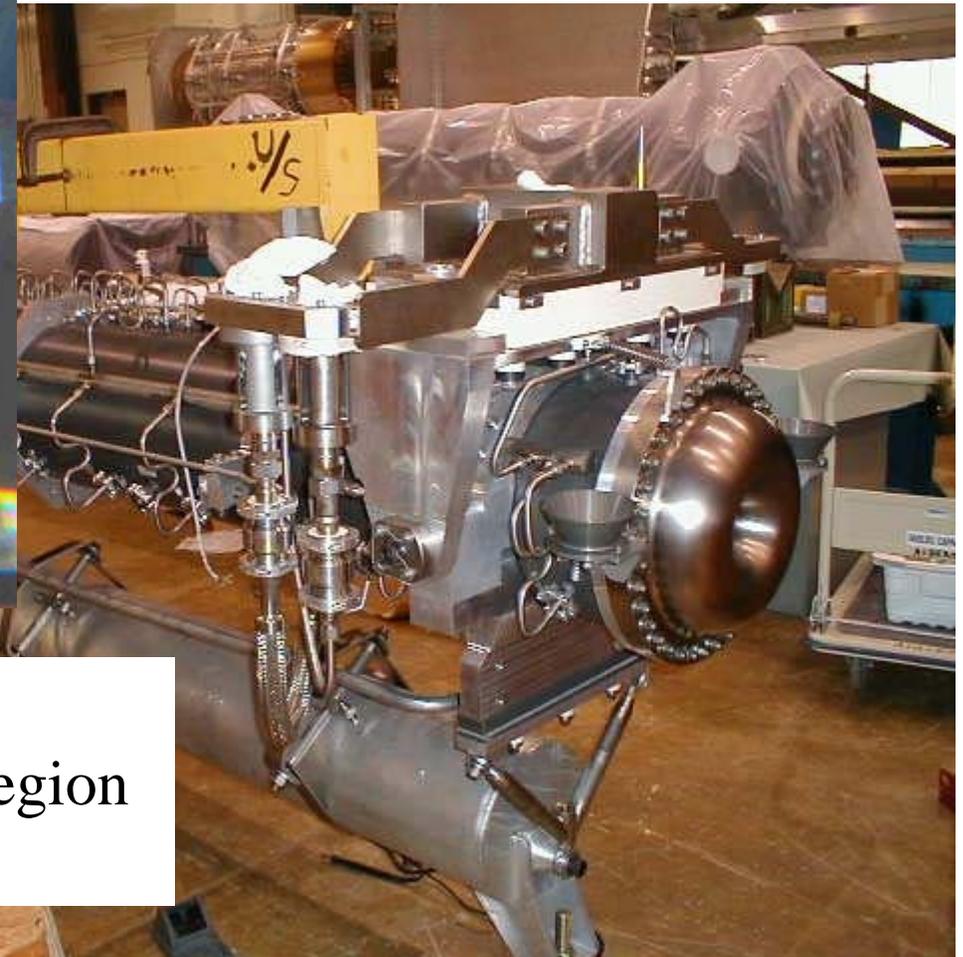
# PH1-01 Failed Ceramic Isolator Location

Leaking Isolator Assembly  
US Beam Left--Higher Radiation Region  
Compared to Horn 2

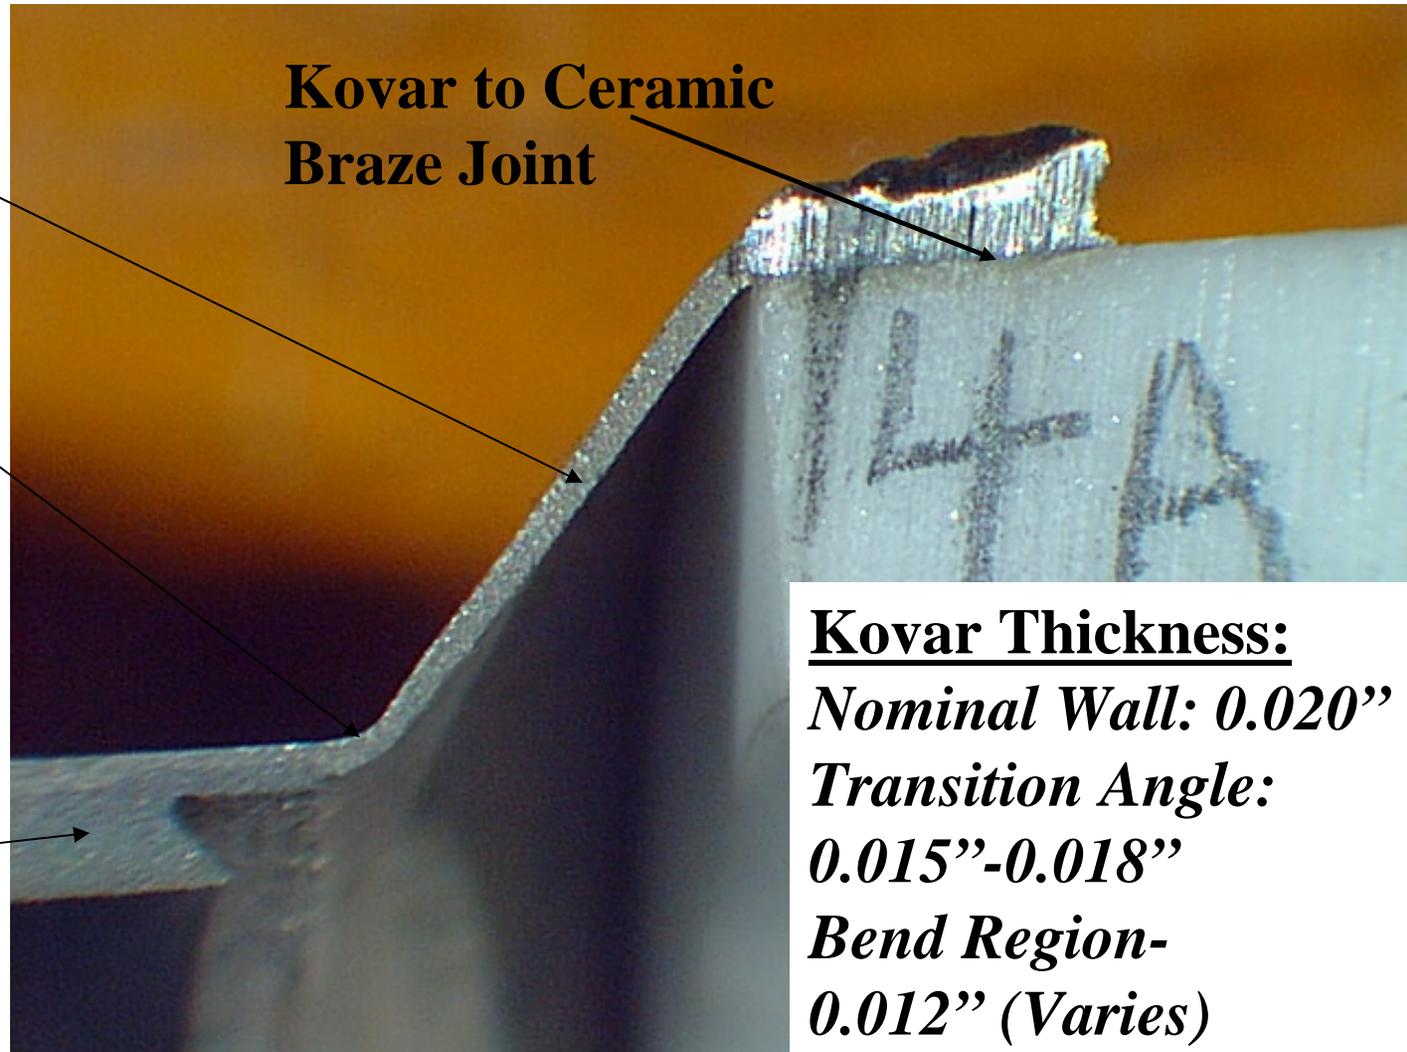
# Cross-Section of Vendor Part New Ceramic Isolator

Tapering  
Wall  
Thickness

The Area  
Of Interest

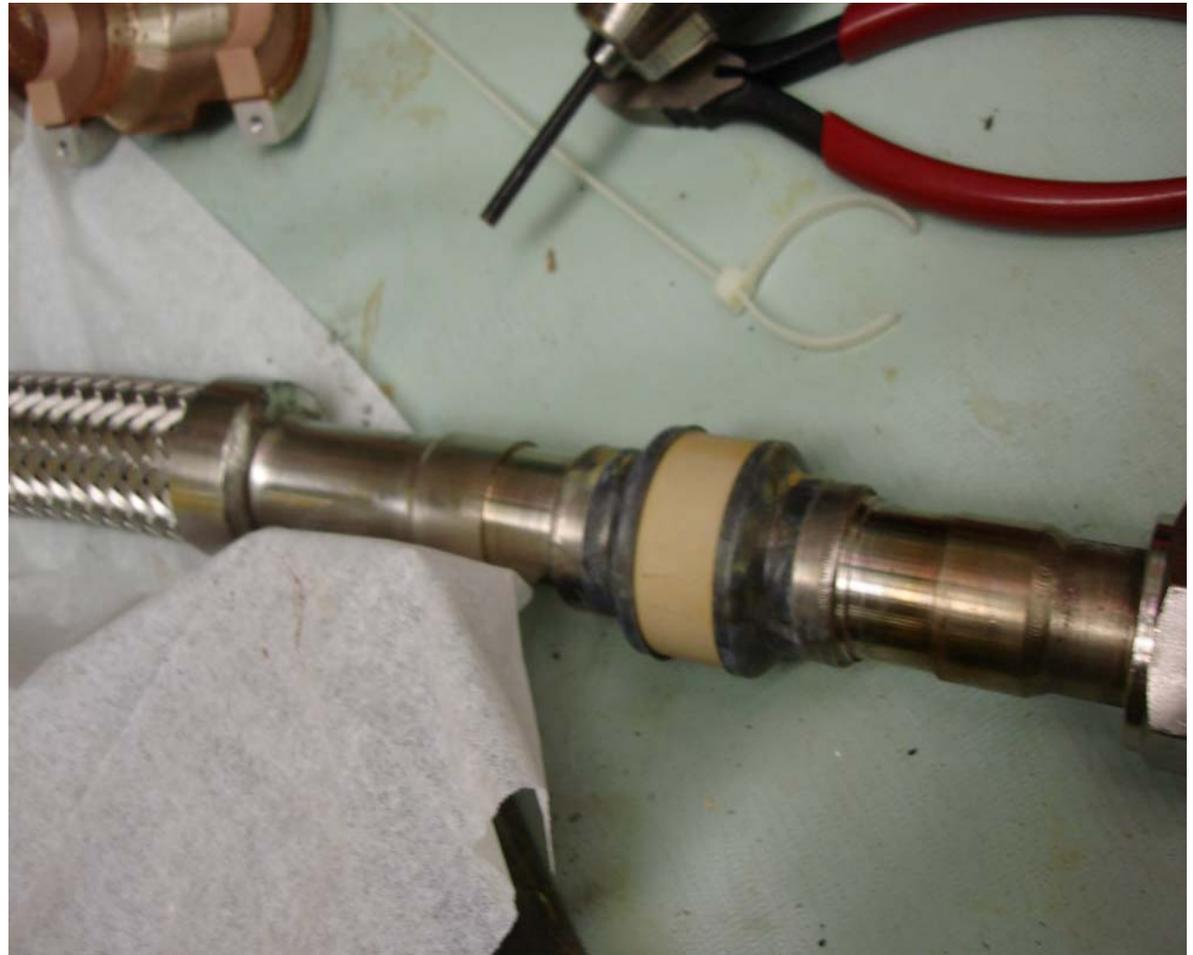
# Horn Water Line Ceramic Isolator-Horn 1 Leak

## Horn 1 Leak- Hardware General Appearance After 1.6E20 POT

- *Alumina Ceramic Intact*
- *Stainless Steel Hardware Appearance OK*
- *Kovar Transition Dull Gray-Covered by Oxide Layer*
- *Invar 36 Shell Rust Layer Noted on External Surfaces*

*Not Terrible in Appearance  
Considering Its Operational  
Environment.....*

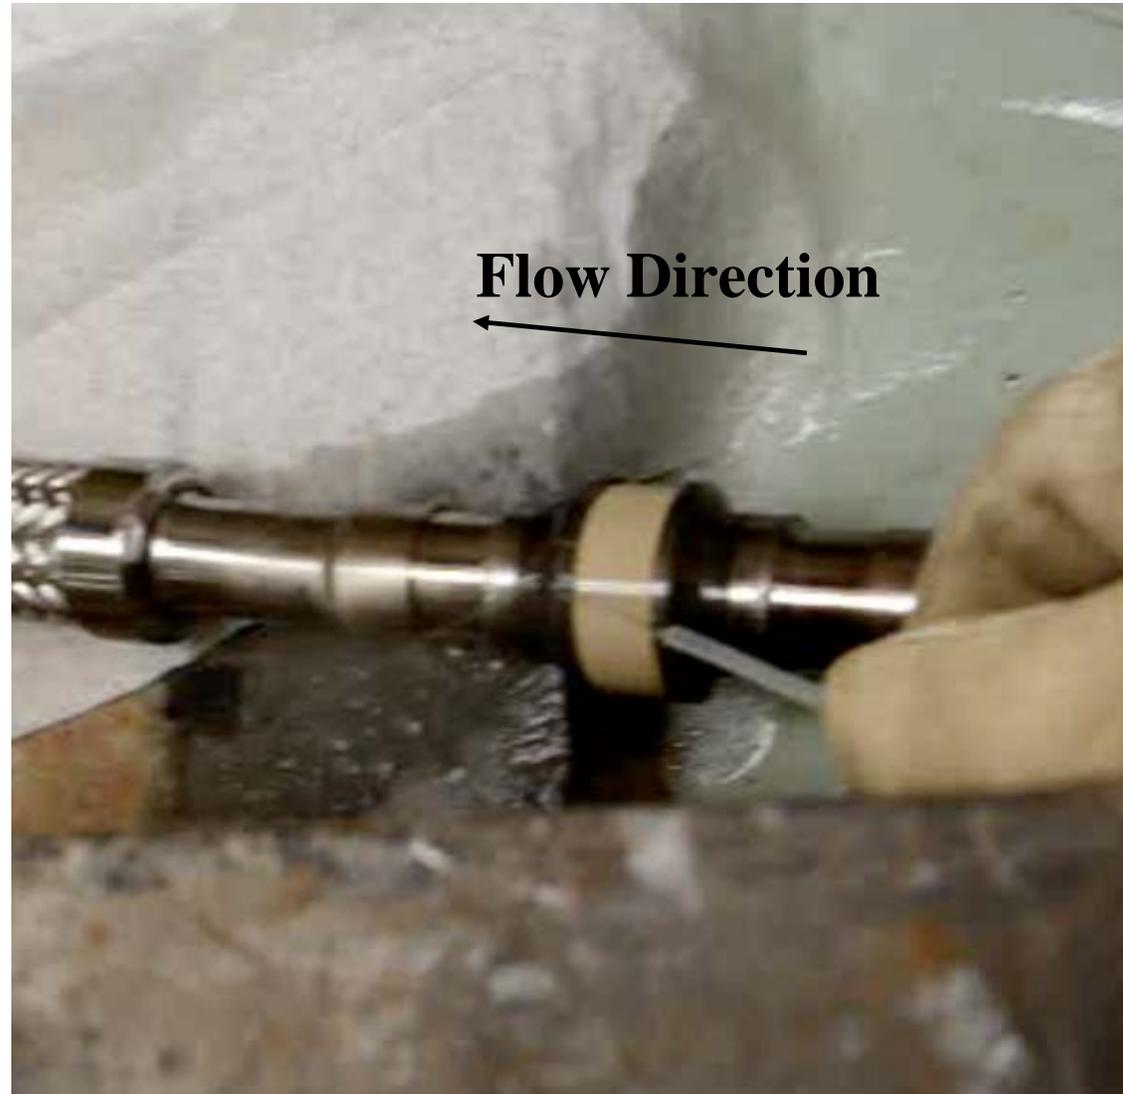
# Horn Water Line Ceramic Isolator-Horn 1 Leak

## Horn 1 Leak

- *Corrosion pit in Kovar near transition bend region*
- *Small hole, estimate few mils diameter (not precision measurement), Size consistent with leak rate*
- *Location- downstream end of flow direction on Kovar transition angle*
- *Low flow velocity, ~3 ft/sec*
- *Braze Joints Intact*

- *Corrosion Pit, Perhaps Due to Thin Wall Section or Material Inclusion in Kovar Base Metal*
- *Unlikely That Fluid Erosion Accelerated Failure - Low Flow Velocity*

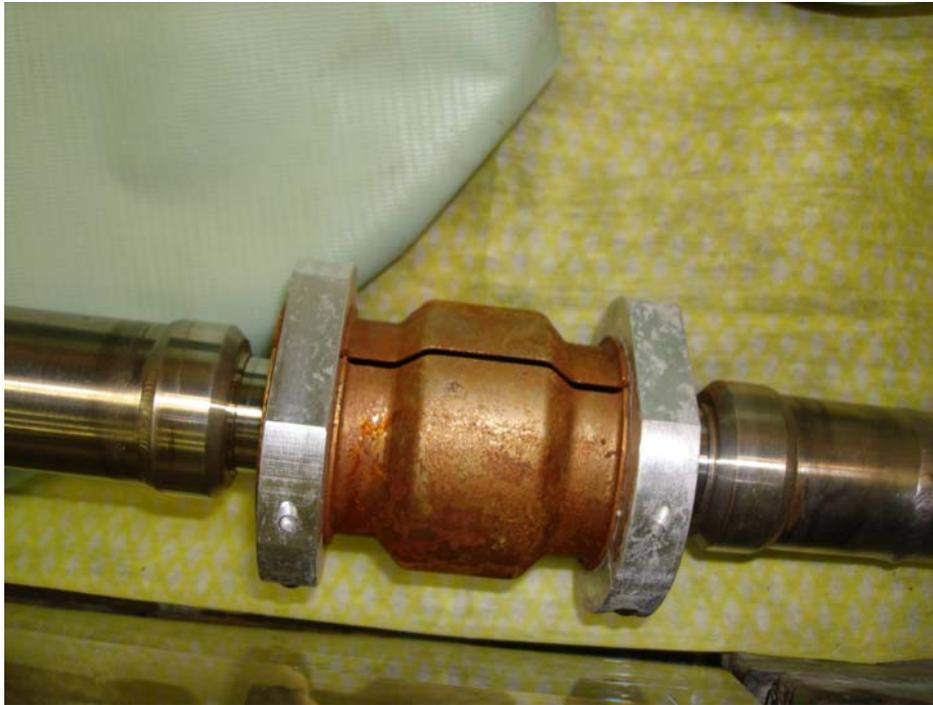
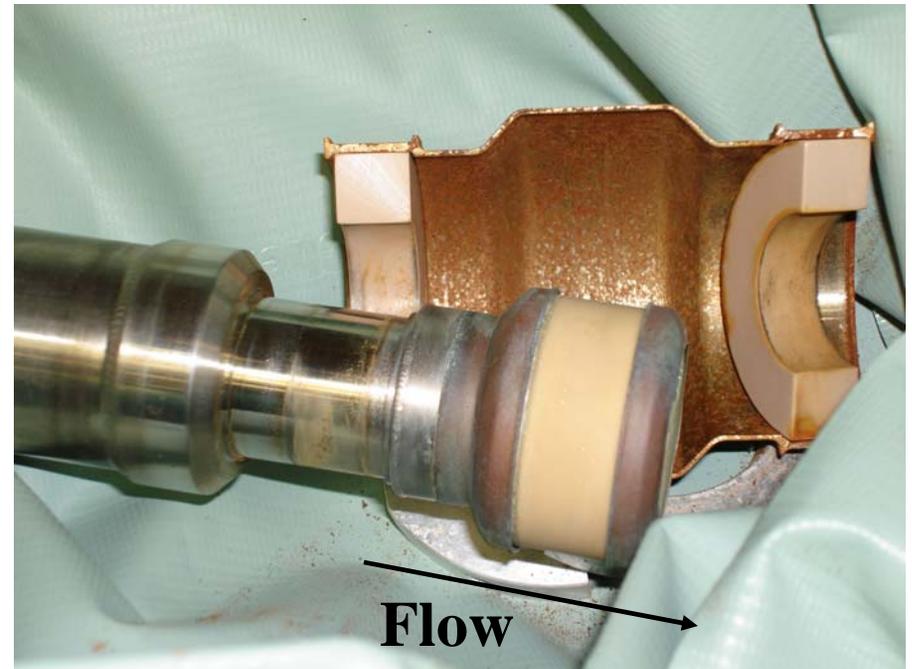
# Horn 2 PH2-01 Ceramic Isolator

Prior To Invar Shell  
And Clamp Removal

Now Have 2 Sections

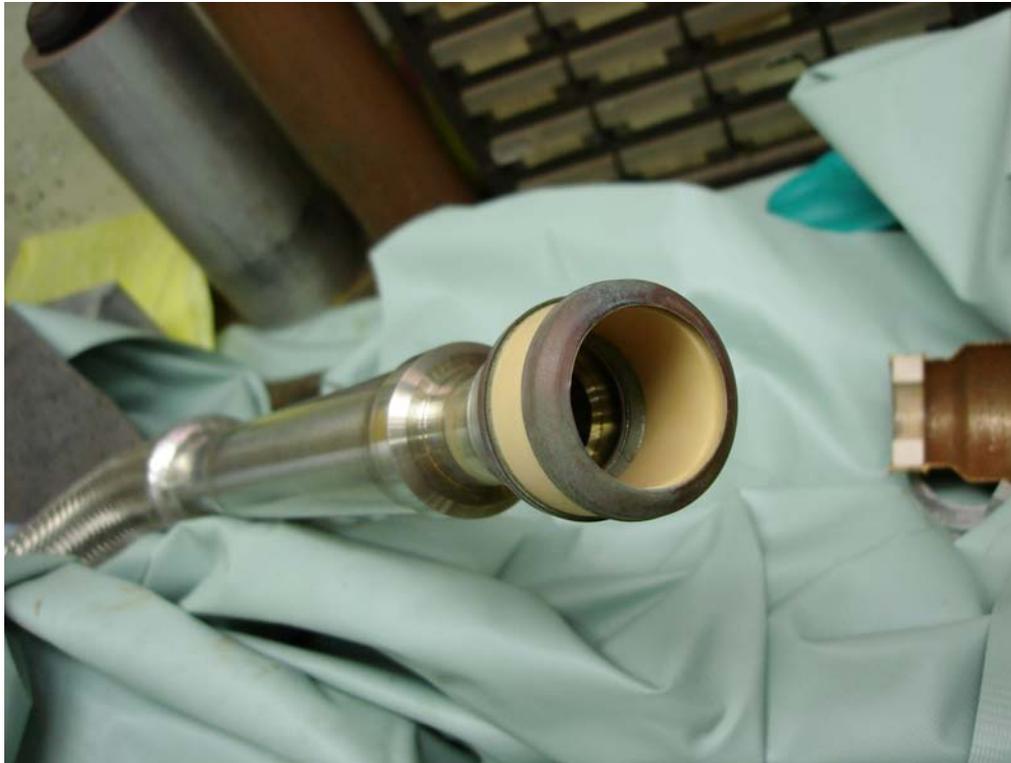
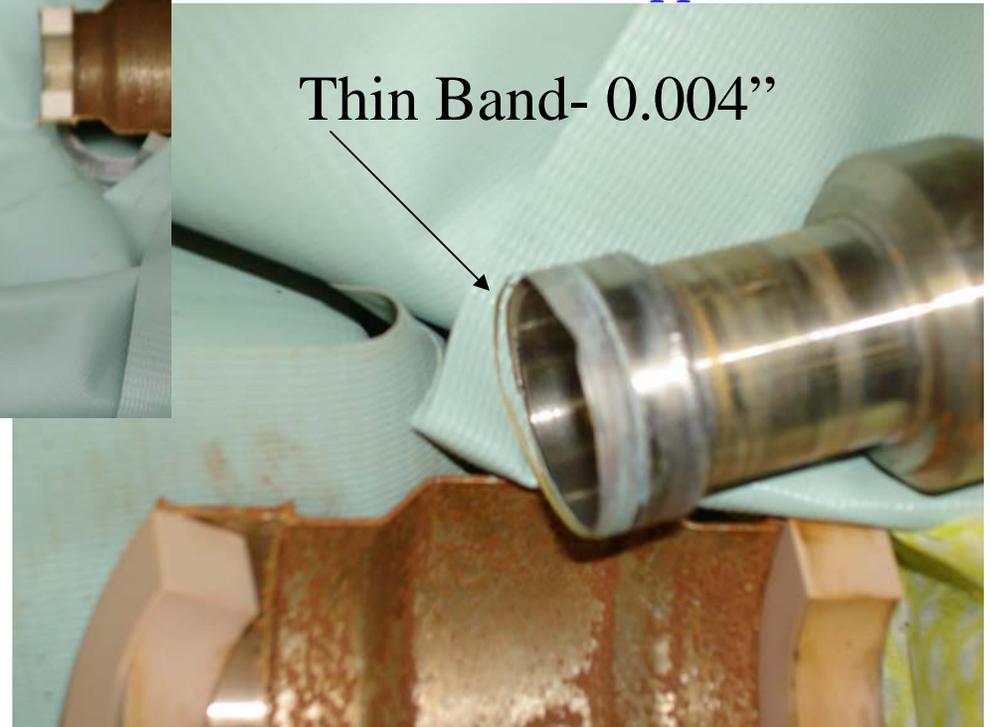
# Horn Water Line Ceramic Isolator

## Fracture at Geometry Change

- Thin Wall*
- Stress Concentration Area*
- Located in DS Flow Path*
- Shear Failure Appearance*

Thin Band- 0.004"

- *Thin Wall and Stress Concentration at Geometry Transition*
- *Possible Kovar Wall Variation and Lack of Consistency Due to Fabrication Technique (Spinning)*
- *Erosion from Flow, DS Side Turbulence (Note: Flow Velocity Only ~8 ft/sec, but Ejector Pump Check Valve Exhibits Cyclic Operation Causing Turbulence)*
- *Split Clamp Preload Loss on Invar Shell Would Result in Torque on Ceramic Isolator Due to Mechanical Vibration of Current Pulse Transmitted Through Suction Line Mass*

- *0.0020''-0.0025'' Shrink Fit, Assembled at 300°C- Eliminate Braze Alloy and Thin Kovar Material Requirement*
- *Thick Cross-Section Ends Featuring 316L SS Tapered Ends for Long-Term Corrosion Considerations*
- *99.8% Alumina Ceramic Isolator- Operational Experience Indicates This is Suitable Material*
- *Still use Invar Support Shell*
