MINOS Status Report

FD refurbished DAQ

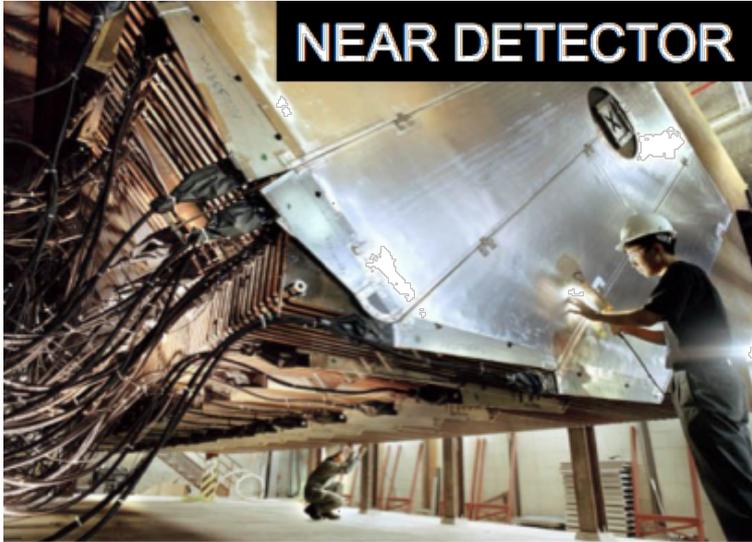
- We were able to fix most of the readout problems (Minders not read out or hot):
 - In some cases we had to replace the Minder with a spare
 - In others we had to replace the Master board
 - We are down to very few spares Minders and Masters boards
 - The bad boards will be sent to Argonne for repairs this week

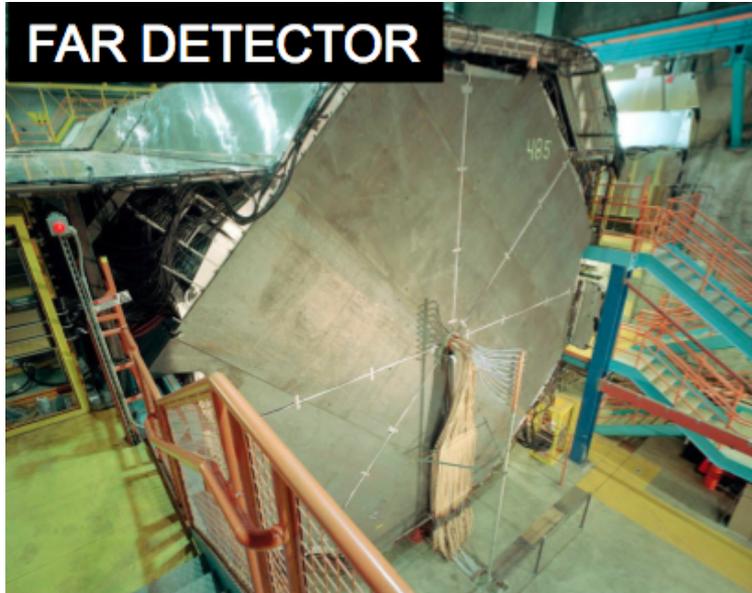
- DAQ problems in Branch 3 [ROP 7-9-11]:
replaced almost every component in the Branch
 - Optical & Differential PVIC cards
 - ROP11 (twice)
 - Copper cable between ROP09 and ROP11
 - Optical PVIC on ROP07
 - Power Supply for Crate 11
- Still investigating sporadic crashes in Crate 11
- All other crates running fine

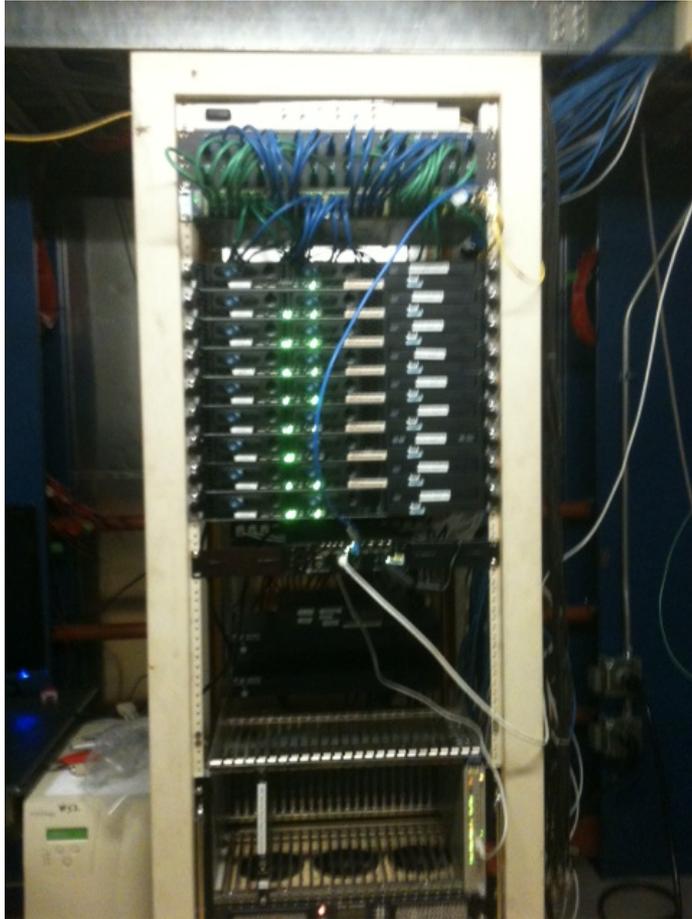
- The new DAQ rack is located on the mezzanine floor near the detector
 - network has been setup
 - MINOS online code has been deployed
 - all 8 DAQ computers and the gateway are operational
- Progress has been made using the PREP test stand here at FNAL to understand some readout issues.
