MINOS Status Report

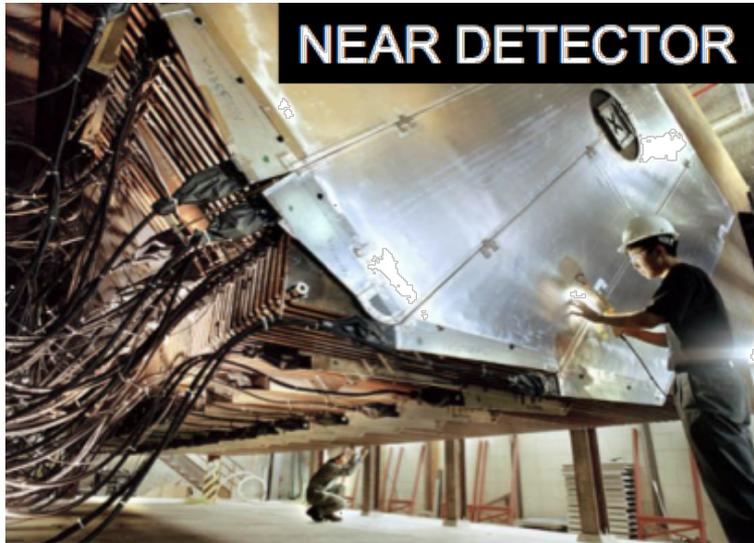
- Still investigating some readout issues
 - anomalous erratic Pedestal patterns
 - similar effects in Singles rates plots
- General work plan is to address and fix hardware issues to keep detector ready for beam
 - 3 problems channels (hot/warm/dead)
 - need to replace Minder boards
- Spares situation
 - 6 Minders repaired at Argonne
 - 12 new being assembled at Argonne
 - 1 working VTM : 2 to be repaired (rarely break)

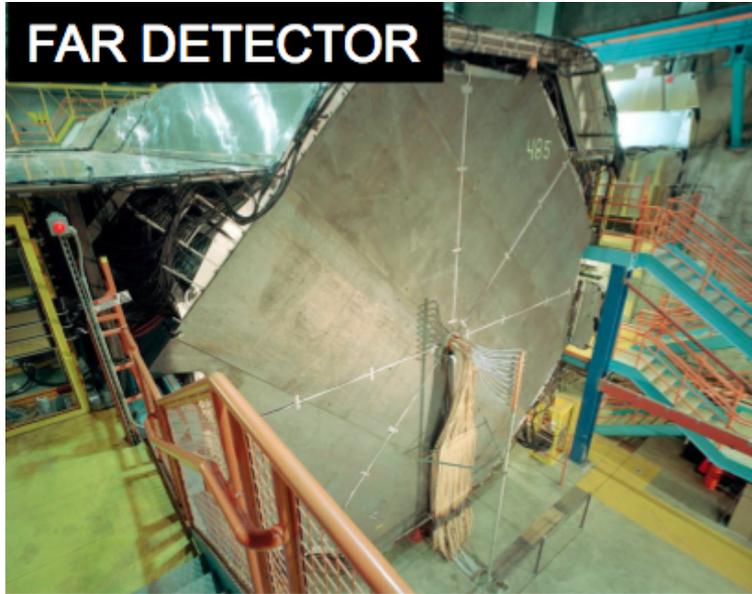
- Developed readout and DAQ issue on Branch 2 this past Saturday
 - working on resolving it (swap in spare boards etc.)
- RPS alarms on Crate 15
 - working on it
