NuMI-MINOS Status Report - Christopher White

NuMI: A reasonable week for POTs, but a bad week for the NuMI target...

Week ending 00:00 Monday 10 May 2010

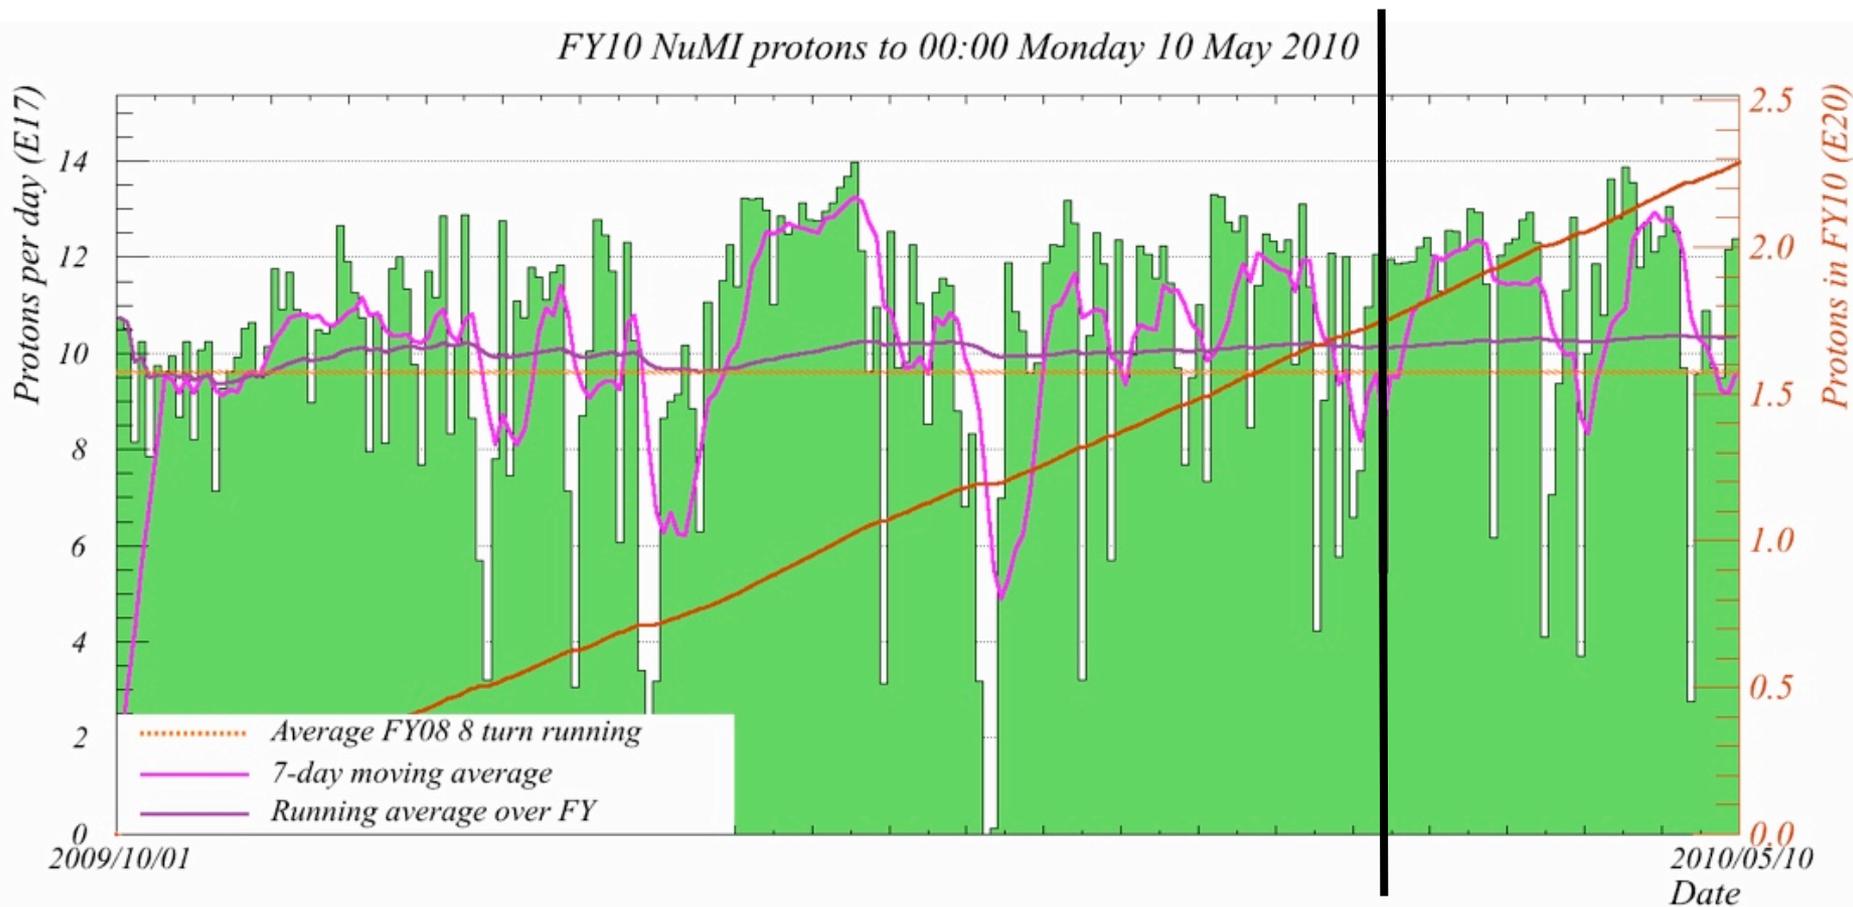
Protons on Target for FY10

RHC: 1.74×10^{20} POT
FHC: 0.54×10^{20} POT

FY09: 2.18×10^{20} POT

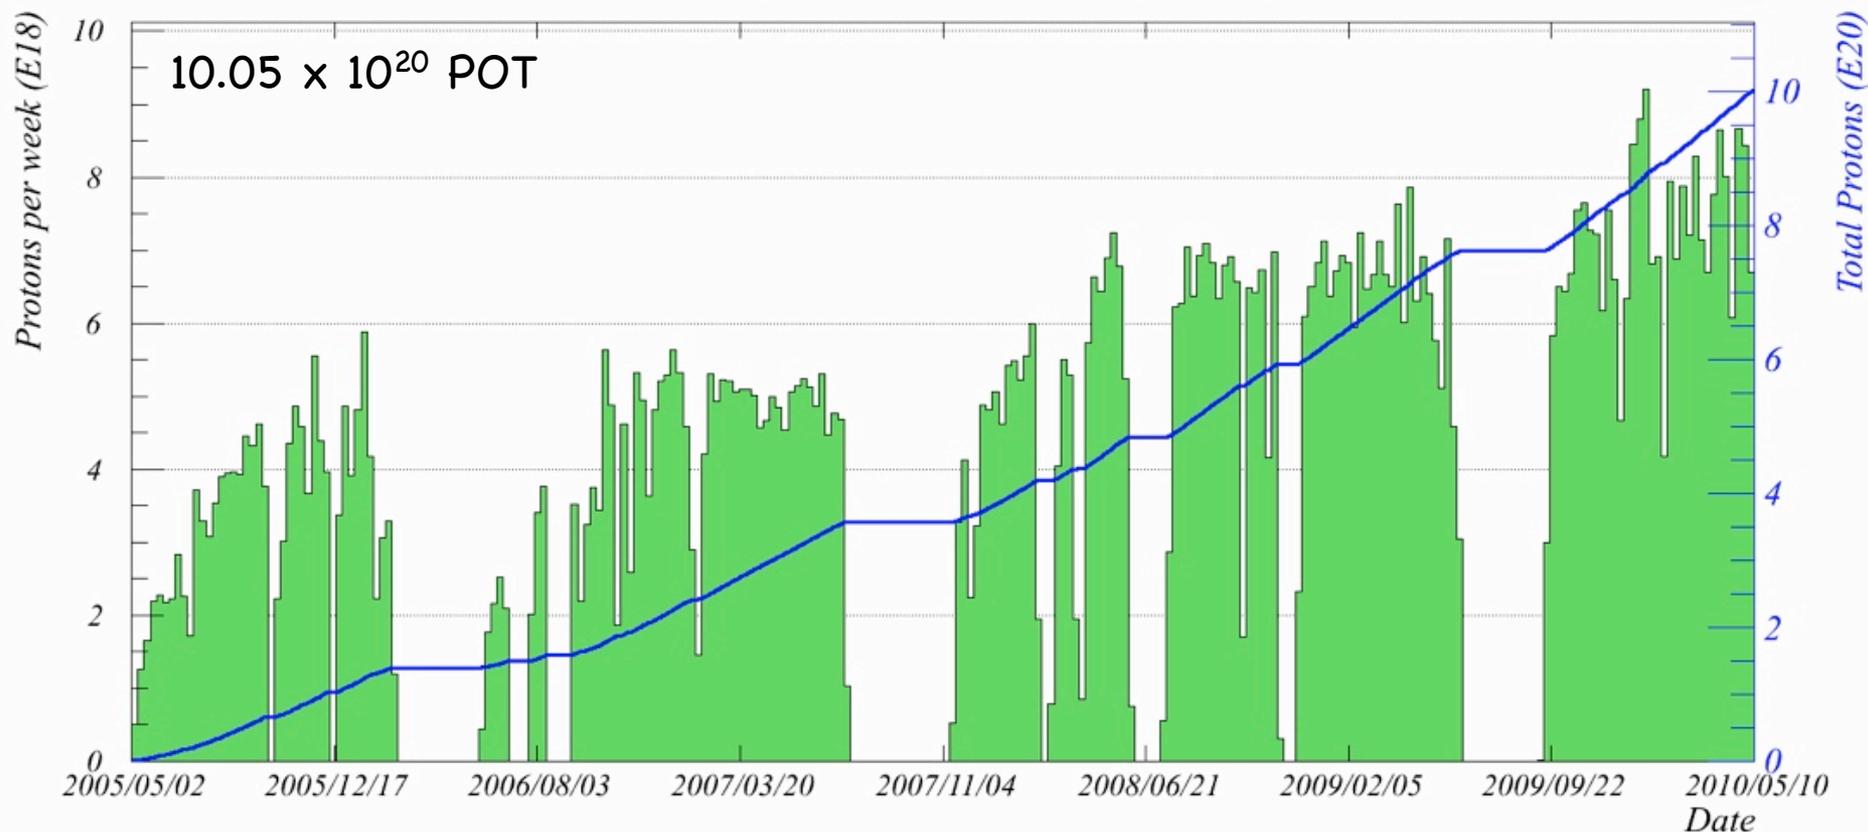
Protons on Target (since 2005)

Total NuMI protons to 00:00 Monday 10 May 2010

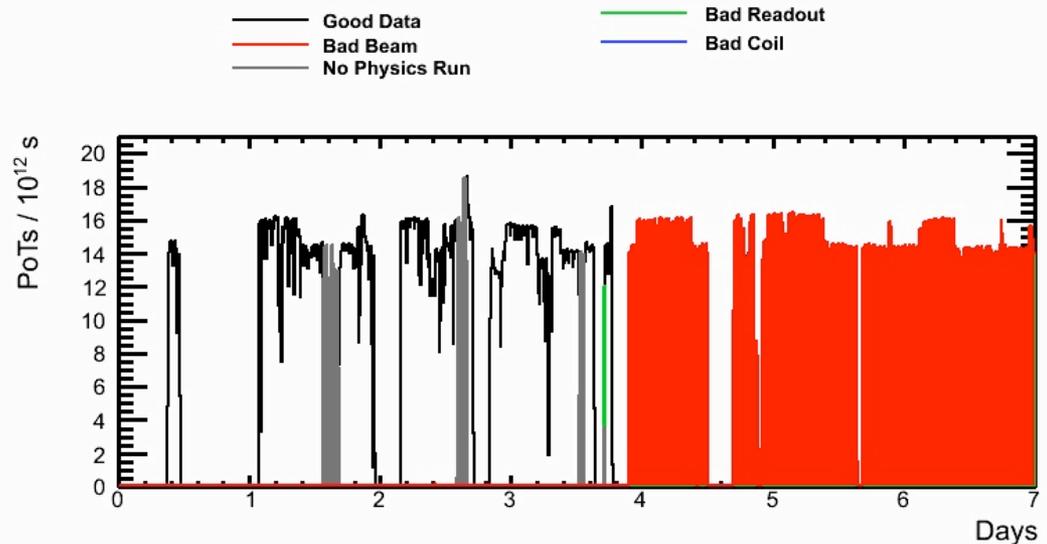
Near Detector
95.5% live

Start: Mon, 03 May 2010 00:00:00 End: Mon, 10 May 2010 00:00:00

Assortment of hot and noisy channels that were reset and re-calibrated (normal).

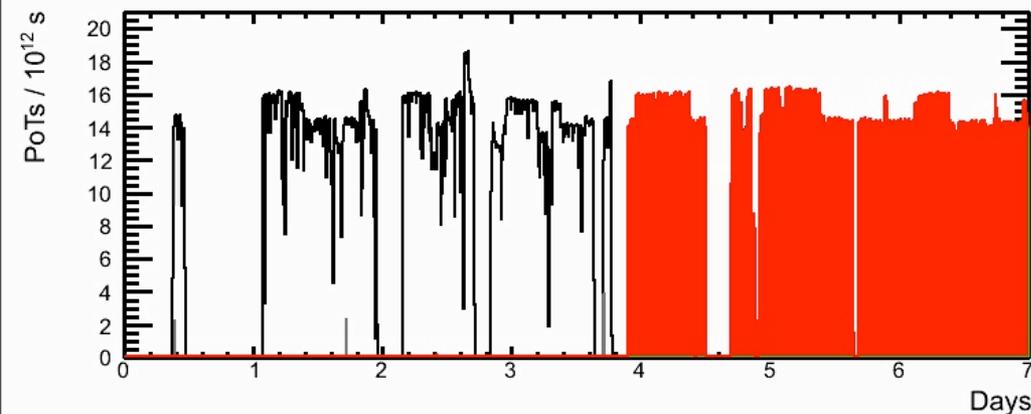
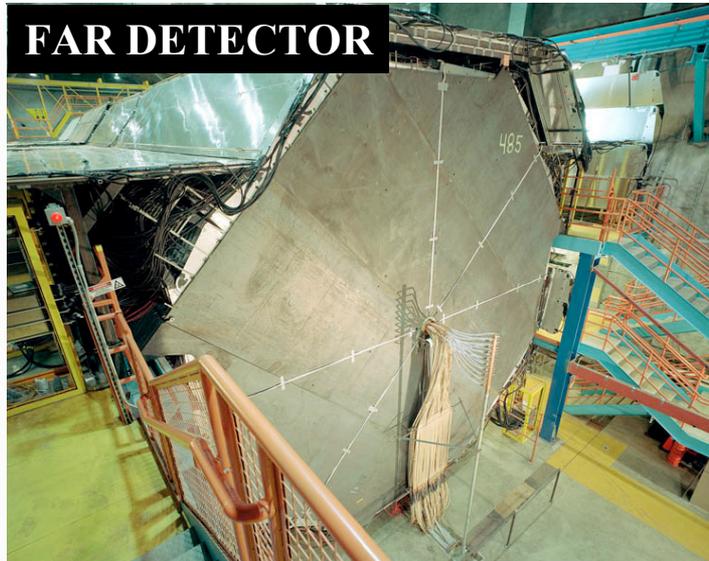
Far Detector
99.5% live

Start: Mon, 03 May 2010 00:00:00 End: Mon, 10 May 2010 00:00:00

Intermittent network problems persist... An annoyance for now but could be serious trouble at any moment. An upgrade has been in the works for years. We sincerely hope to secure funds, procure equipment, and complete the upgrade before the end of the summer shutdown.

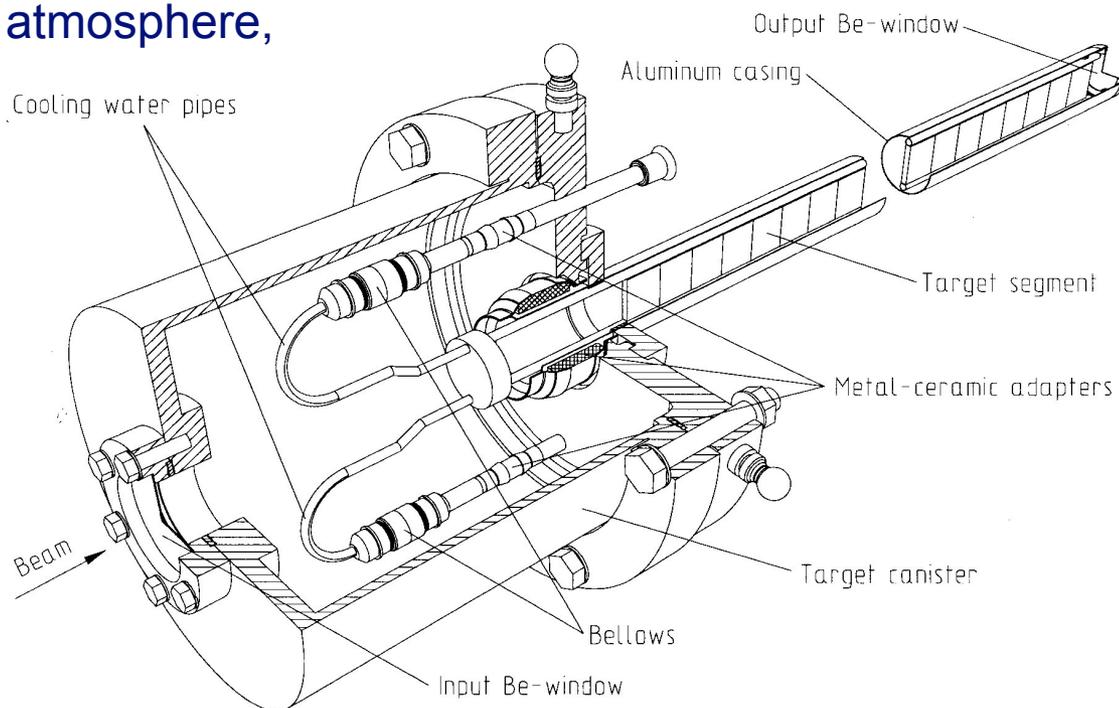
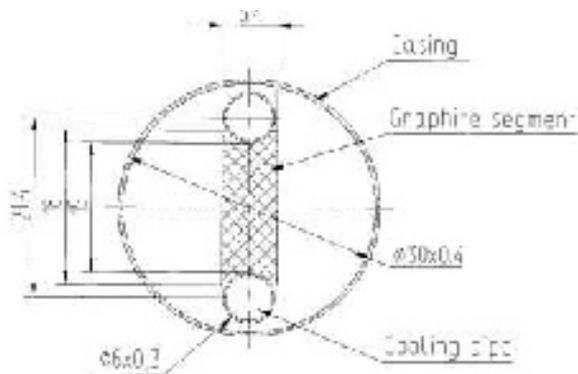
NuMI-Target

Graphite Fin Core
(6.4 mm x 15 mm x 20 mm) x 47 segments

Water cooling tube also provides mech. support
(steel soldered to graphite)

0.4 mm thick Aluminum tube (He atmosphere,
Be windows at U.S. and D.S. ends)

Ceramic electrical isolation

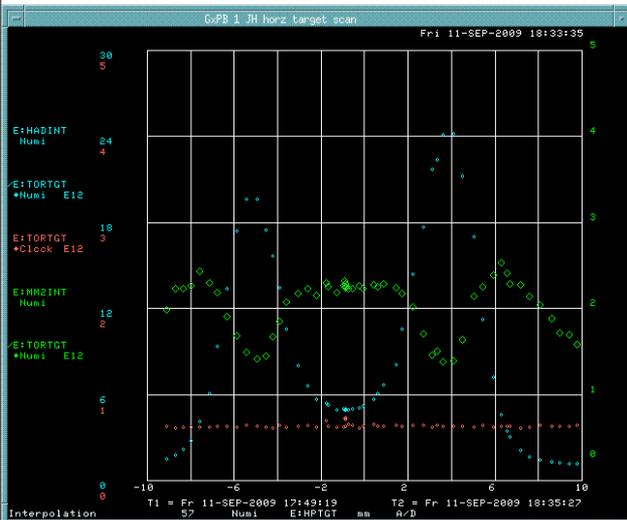
Scan from 9/09

A beam scan (“x-ray”) of the target on May 6th verifies that the target has shifted.

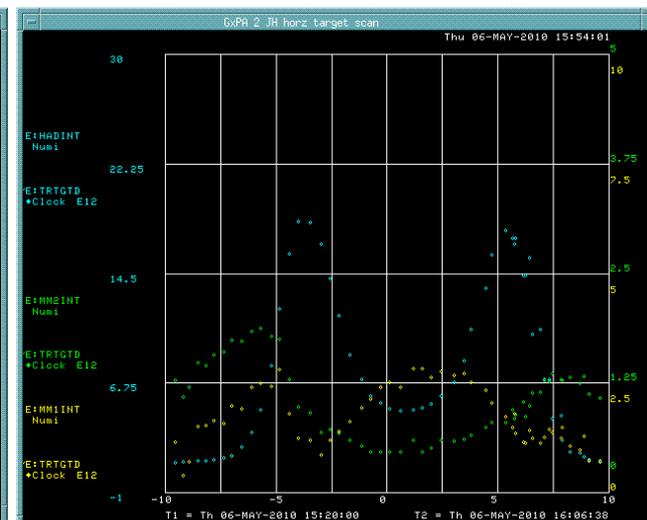
Scan on May 6 (PM)

Transverse motor drive was used to re-position the target horizontally.
