NuMI/MINOS: Oct 9-16 '06

HV101-2 Water Leak Repair

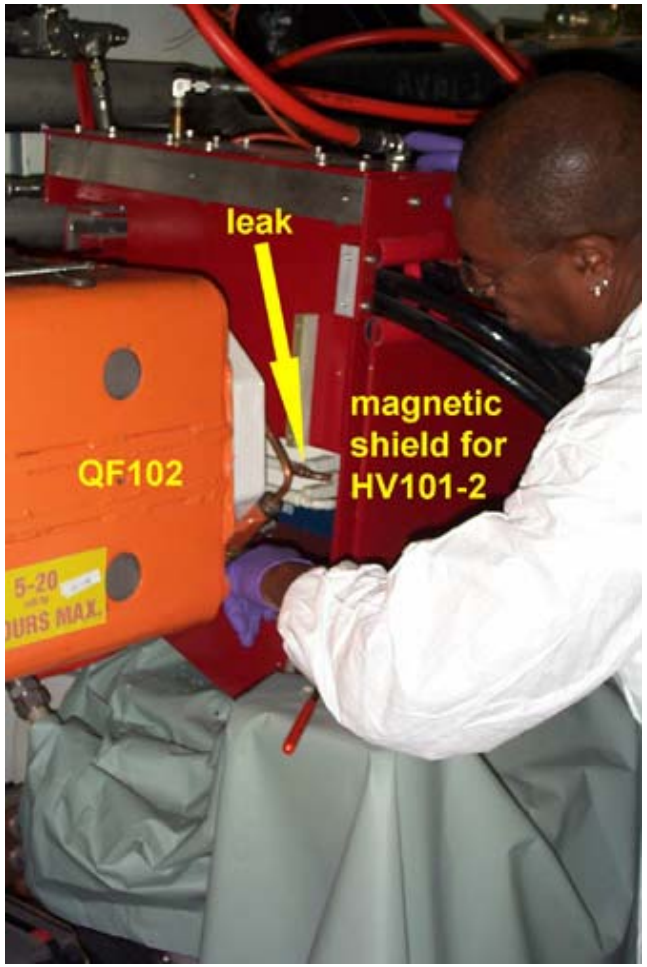
Very fortunate in several respects: Leak was accessible and at a braze joint.

- Successful repair of HV101 water leak in situ at beginning of TeV down time!!
  - « Would have been a several day magnet replacement effort if this had not been successful.
- Resume NuMI beam operation (6 batch NuMI only mode late on Wed. Oct.11.) Then 2+5 batches from Friday Oct.13.
  - « Several hours of downtime on Friday for HV101 Power supply repair
- NuMI beam power increased from ~ 150 kW (with I- source problems) to 230 - 260 kW for much of week-end
- Excellent uptime for MINOS near & far detectors >99%

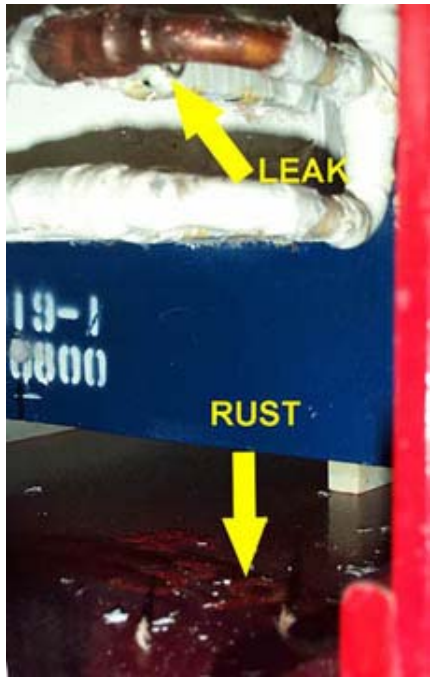
Magnet is tightly positioned between MI and Recycler. Difficult access to remove/install, and also would have to remove/install dual fringe field protection shields
