# NuMI Horn Water Line Ceramic Isolator Overview

NuMI Horn Water Line  
Ceramic Isolator  
Special Report AEM  
July 16, 2007

## Horn Water Spray Supply Line Electrical Isolators- Operational Experience With First NuMI Horns

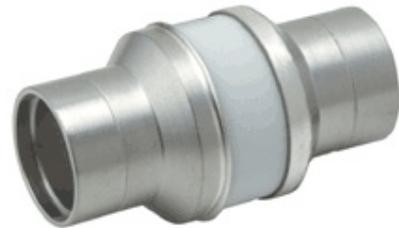
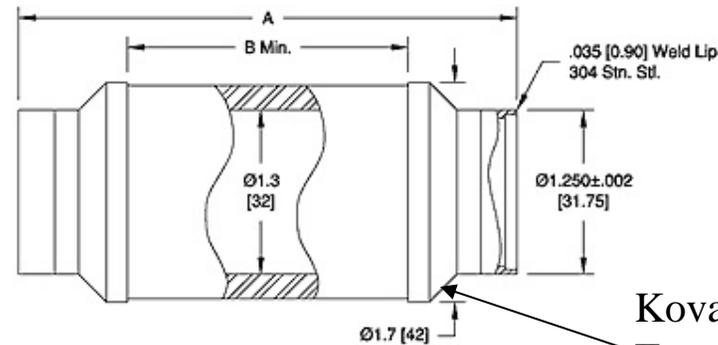
# Ceramic Isolator- Vendor Part Ceramaseal

- **Kovar- 29%Ni, 17%Co, Trace Si&Mn, Balance Fe (Low Expansion Alloy)**
- **0.020” Nominal Thickness, Yield Strength=50ksi, UTS=75ksi, 30%Elongation**
- **Transition Piece Fabricated by Spinning, Brazed to Ceramic with Ag Braze Alloy**
- **Moderate Corrosion Resistance, Form Protective Oxide Layer**
