NuMI-MINOS status report

Phil Adamson
Fermilab Accelerator Division

for the
MINOS collaboration

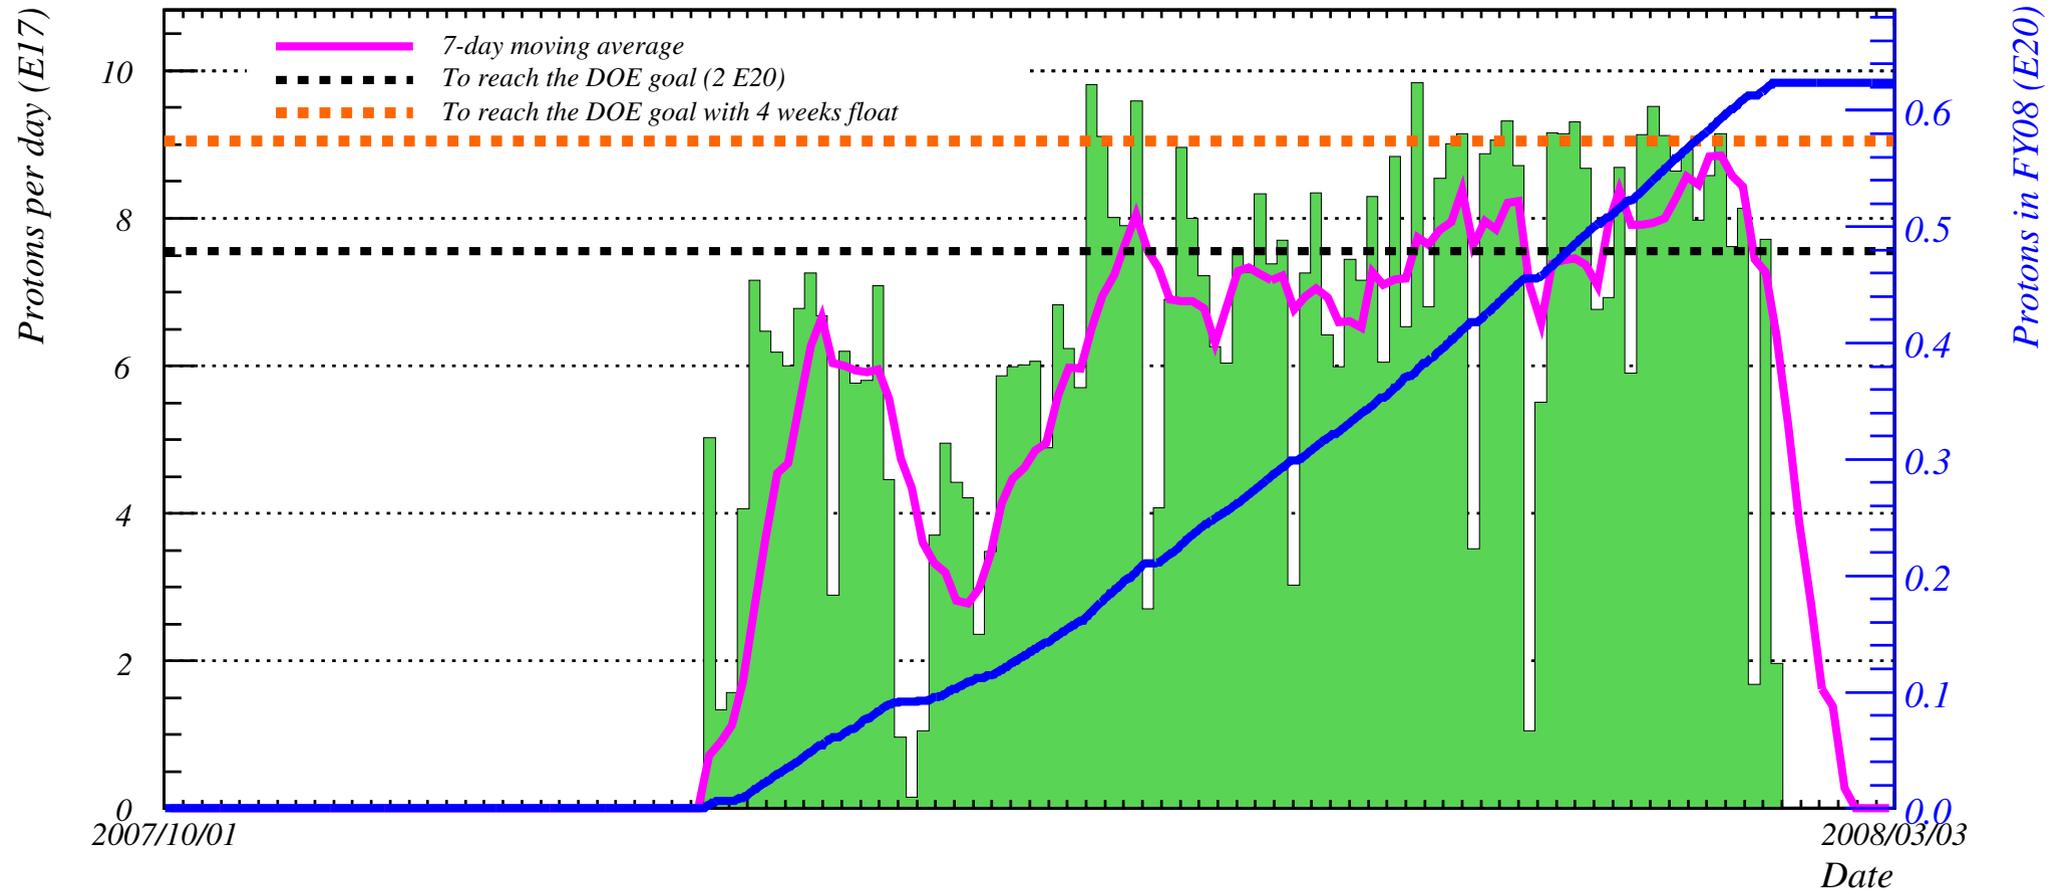
FY08 NuMI protons to 00:00 Monday 03 March 2008

- ▶ Black and orange lines show average needed to reach DOE goal by Labor Day
- ▶ Fermilab “base” and “design” goals are higher
