Detectors and Beam Systems

NuMI-MINOS Status Report — A. Habig

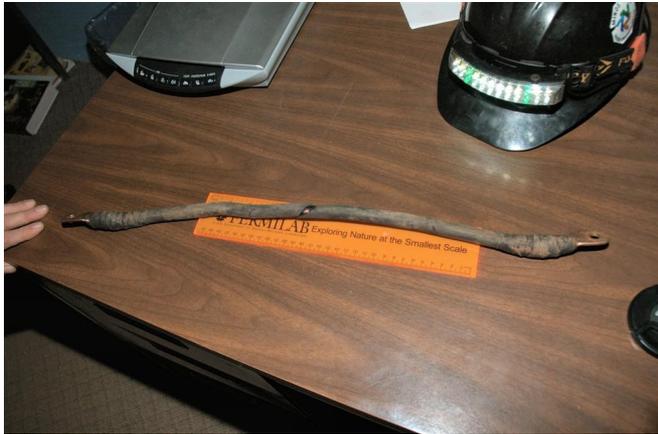
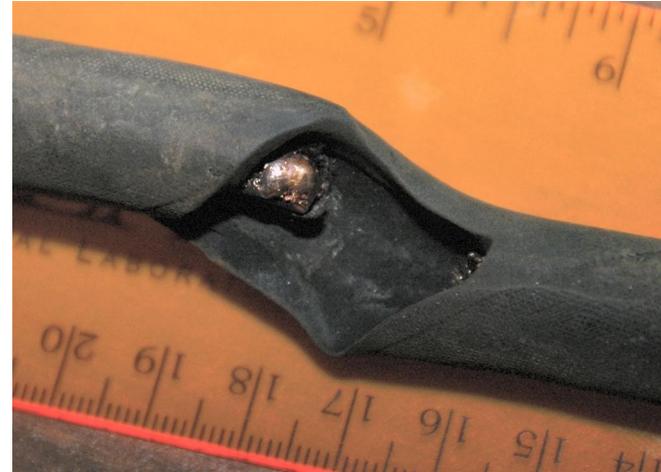
- FAR DETECTOR: Alec Habig
- One leg of the jumper between Mine and Lab power boxes on the 27th level was burnt in two by the lightning strike:

- Resulted in operation of lab with 2 of 3 phases for a few minutes, but the UPS's and power conditioners protected the experiments perfectly throughout all this
